**Flood Control Project Maintenance
Levee Inspections**

Fall 2012 Levee Maintenance Deficiency Summary Report

San Joaquin River Basin

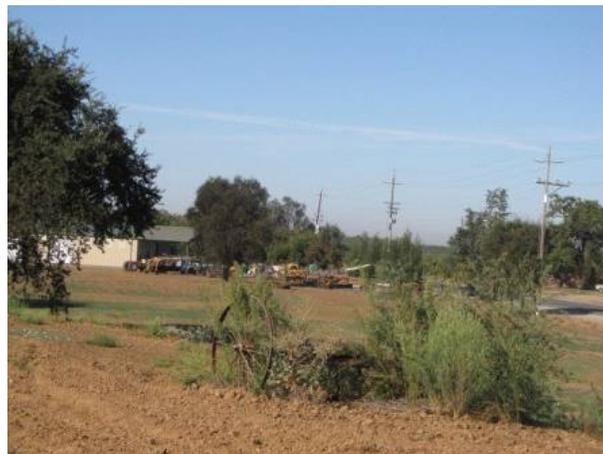
pkazi_f_20120913_319.jpg

Levee Mile Report Line	18
Start Levee Mile	2.43
End Levee Mile	2.43
Location	Land Side
Category	Earthen Levee
Item	Encroachments

View of equipment on the landward slope of the levee looking downstream.

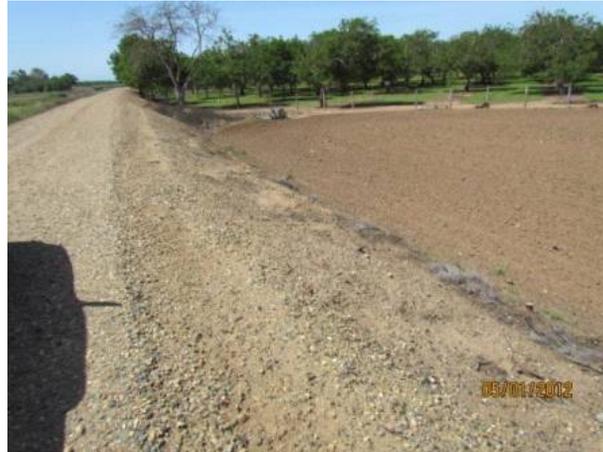
Levee Mile Report Line	19
Start Levee Mile	2.59
End Levee Mile	2.59
Location	Land Side
Category	Earthen Levee
Item	Slope Stability
Slope instability was found on the landside slope of the levee looking downstream.	
pkazi_f_20120913_328.jpg

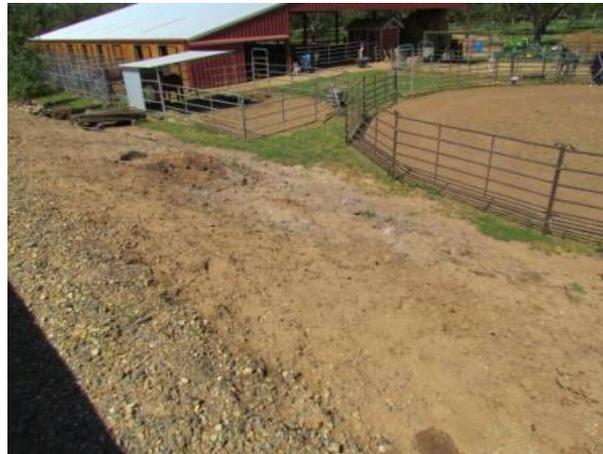
Levee Mile Report Line	21
Start Levee Mile	2.68
End Levee Mile	2.68
Location	Land Side
Category	Earthen Levee
Item	Slope Stability
Slope instability was found on the landside of the levee. The picture was taken from the crown looking downstream.	
pkazi_f_20120913_315.jpg

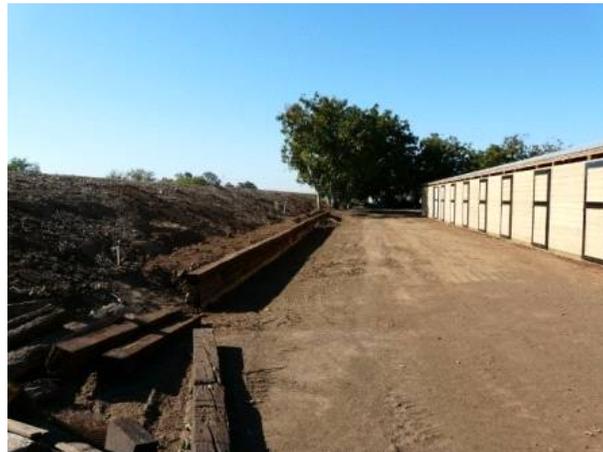
Levee Mile Report Line	22
Start Levee Mile	2.68
End Levee Mile	2.71
Location	Land Side
Category	Earthen Levee
Item	Encroachments
Recently built retaining wall at toe of landside levee at LM 2.68.	
pkazi_f_20120913_343.JPG

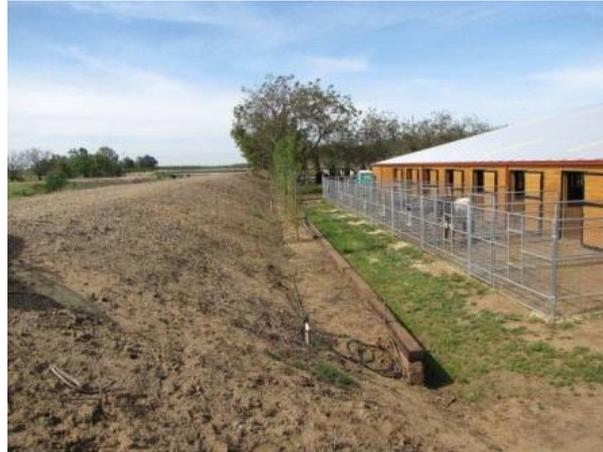
Levee Mile Report Line	22
Start Levee Mile	2.68
End Levee Mile	2.71
Location	Land Side
Category	Earthen Levee
Item	Encroachments
Updated view as of spring 2009. Landscaping and irrigation have been added at the toe of the levee.	
pkazi_f_20120913_344.jpg

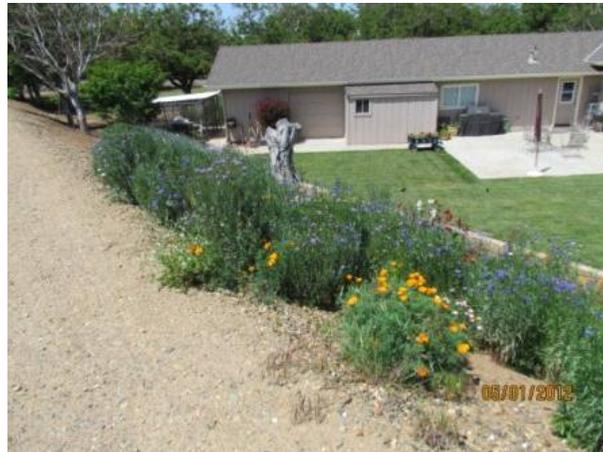
Levee Mile Report Line	23
Start Levee Mile	2.73
End Levee Mile	2.73
Location	Land Side
Category	Earthen Levee
Item	Vegetation
Landscape was found on the landside of the levee looking downstream.	
pkazi_f_20120913_280.jpg

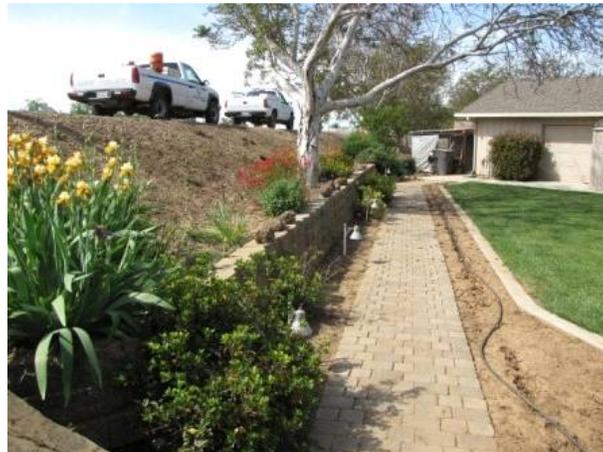
Levee Mile Report Line	24
Start Levee Mile	2.74
End Levee Mile	2.75
Location	Land Side
Category	Earthen Levee
Item	Encroachments
View of retaining wall and landscaping along the landward toe of the levee.	
pkazi_f_20120913_408.jpg

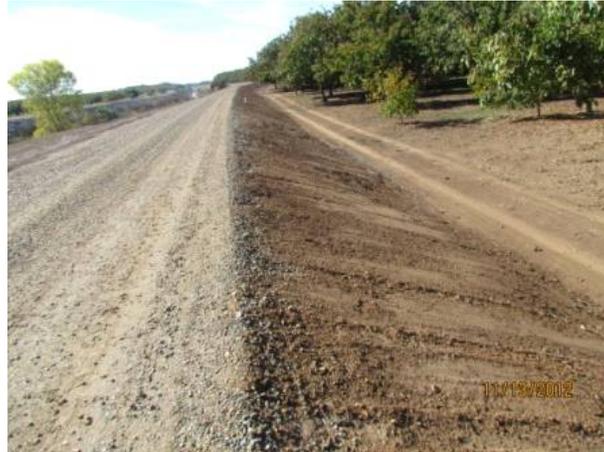
Levee Mile Report Line	28
Start Levee Mile	2.89
End Levee Mile	2.89
Location	Land Side
Category	Earthen Levee
Item	Slope Stability
<p>The LMA has fixed several slope instability issues on the landside slope of the levee looking downstream.</p>	
<p>pkazi_f_20121114_054.jpg</p>

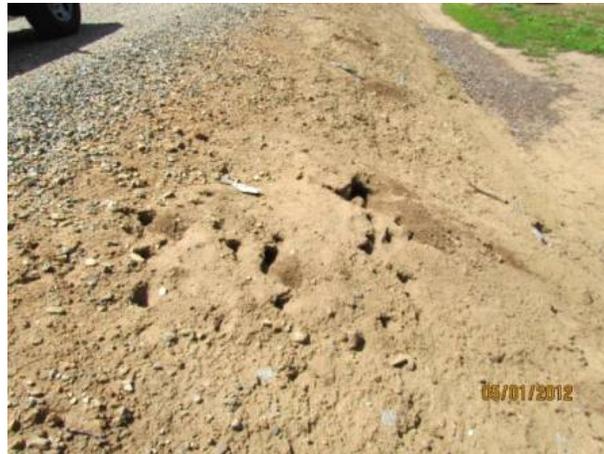
Levee Mile Report Line	29
Start Levee Mile	2.90
End Levee Mile	2.90
Location	Land Side
Category	Earthen Levee
Item	Animal Control
<p>Animal holes were found on the landside of the levee looking downstream.</p>	
<p>pkazi_f_20120913_337.jpg</p>

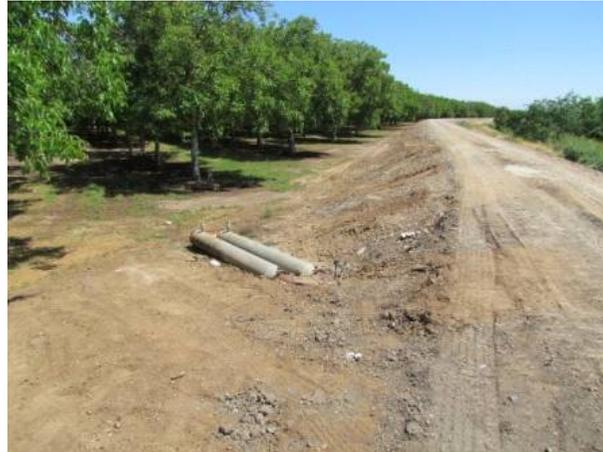
Levee Mile Report Line	35
Start Levee Mile	3.10
End Levee Mile	3.14
Location	Land Side
Category	Earthen Levee
Item	Slope Stability
Slope stability was found on the landside of the levee. The picture was taken from the crown looking upstream.	
pkazi_f_20120913_329.jpg

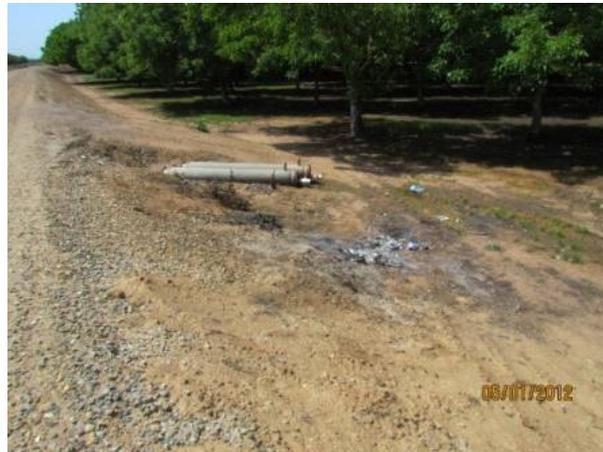
Levee Mile Report Line	36
Start Levee Mile	3.13
End Levee Mile	3.13
Location	Land Side
Category	Earthen Levee
Item	Encroachments
Debris was found on the landside of the levee looking downstream.	
pkazi_f_20120913_341.jpg

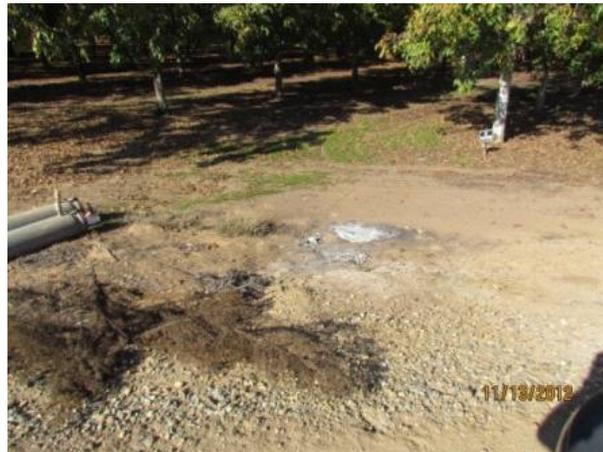
Levee Mile Report Line	37
Start Levee Mile	3.13
End Levee Mile	3.13
Location	Land Side
Category	Earthen Levee
Item	Encroachments
The debris was removed by the LMA at the landside toe of the levee.	
pkazi_f_20121114_056.jpg

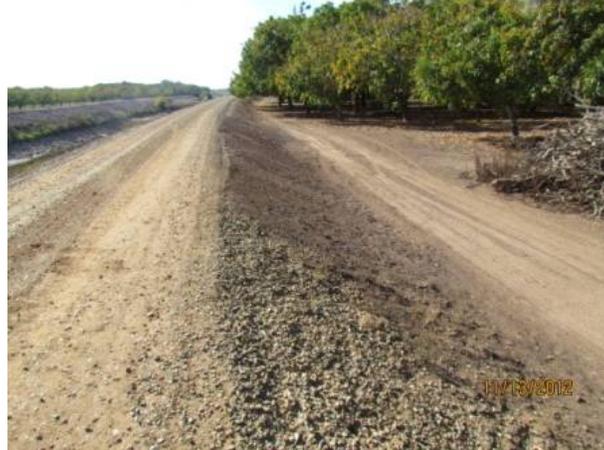
pkazi_f_20121114_057.jpg

The LMA has fixed several slope instability issues on the landside slope of the levee looking downstream.

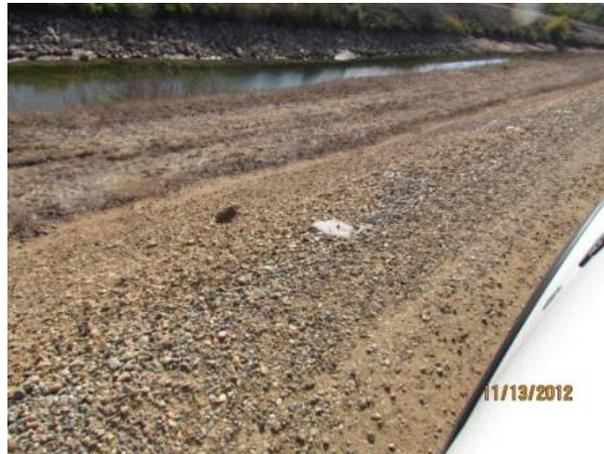
pkazi_f_20121114_058.jpg

Levee Mile Report Line	41
Start Levee Mile	3.23
End Levee Mile	3.23
Location	Water Side
Category	Earthen Levee
Item	Animal Control

The LMA has grouted the animal hole on the landside slope of the levee looking downstream.

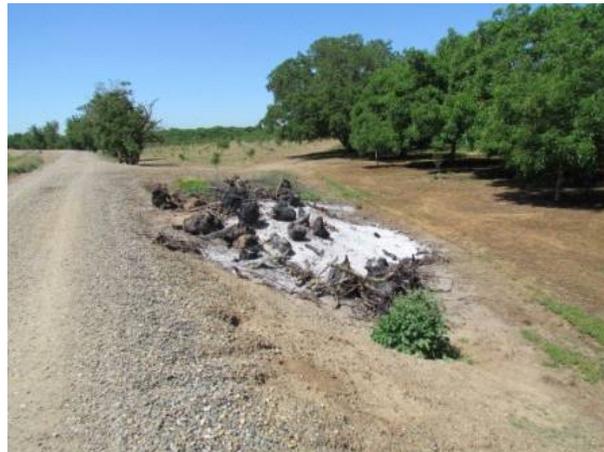
pkazi_f_20120913_293.jpg

Levee Mile Report Line	44
Start Levee Mile	3.40
End Levee Mile	3.40
Location	Land Side
Category	Earthen Levee
Item	Encroachments

Burn pile and new material was placed at the toe of the landside of the levee. The picture was taken from the crown looking downstream.

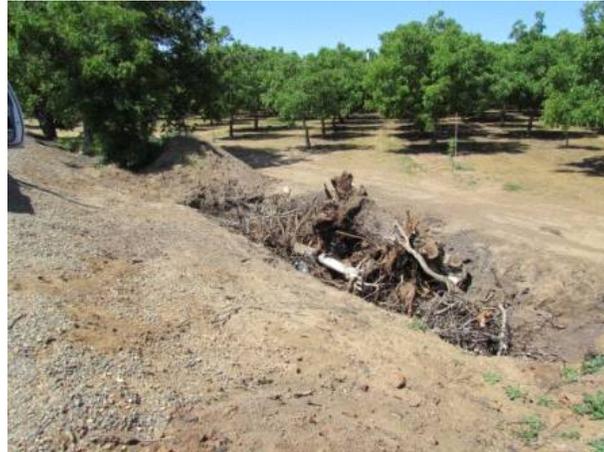
Levee Mile Report Line	48
Start Levee Mile	3.61
End Levee Mile	3.61
Location	Land Side
Category	Earthen Levee
Item	Slope Stability
<p>A pit was dug out by the farmers at the toe of landside of the levee. The picture was taken from the crown looking downstream.</p>	
<p>pkazi_f_20120913_345.jpg</p>

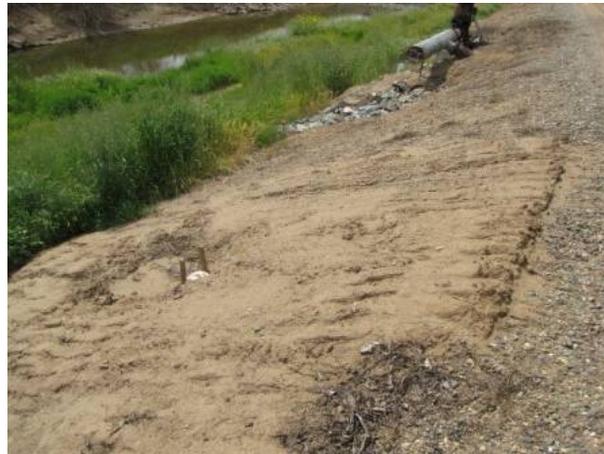
Levee Mile Report Line	49
Start Levee Mile	3.62
End Levee Mile	3.62
Location	Water Side
Category	Earthen Levee
Item	Encroachments
<p>View of a recently place pipe in the waterward slope looking downstream.</p>	
<p>pkazi_f_20120913_332.jpg</p>

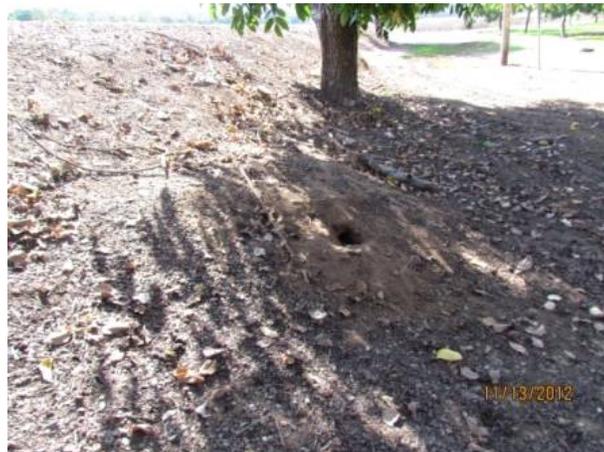
Levee Mile Report Line	50
Start Levee Mile	3.63
End Levee Mile	3.63
Location	Land Side
Category	Earthen Levee
Item	Animal Control
<p>An animal burrow was found on the landside slope of the levee looking downstream.</p>	
<p>pkazi_f_20121114_060.jpg</p>

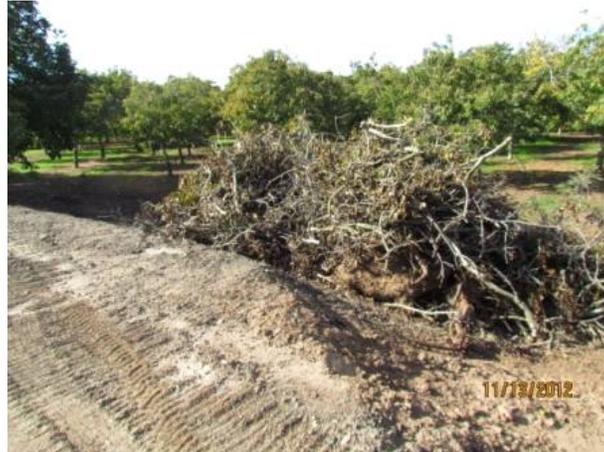
Levee Mile Report Line	51
Start Levee Mile	3.63
End Levee Mile	3.63
Location	Land Side
Category	Earthen Levee
Item	Encroachments
Prunings was found on the landside toe of the levee looking downstream.	
pkazi_f_20121114_059.jpg

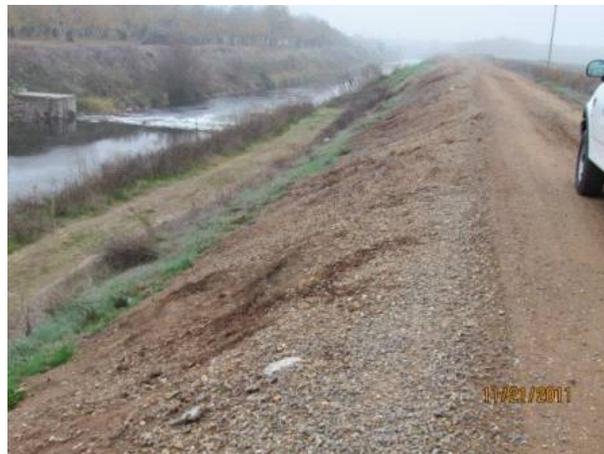
Levee Mile Report Line	52
Start Levee Mile	3.65
End Levee Mile	3.65
Location	Water Side
Category	Earthen Levee
Item	Slope Stability
Slope instability was found on the waterside of the levee looking downstream.	
pkazi_f_20120913_429.jpg

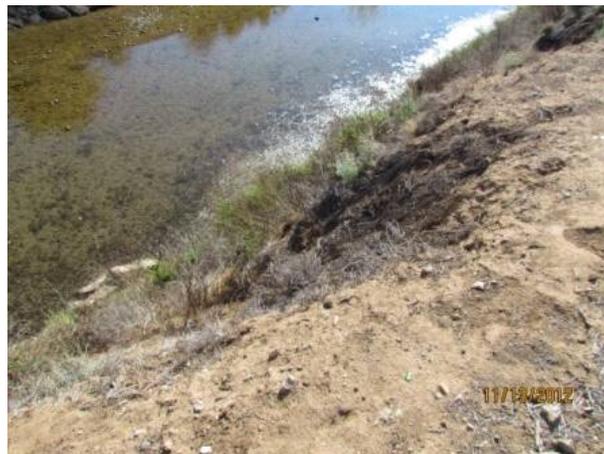
Levee Mile Report Line	53
Start Levee Mile	3.81
End Levee Mile	3.81
Location	Water Side
Category	Earthen Levee
Item	Erosion / Bank Caving
Erosion was found on the waterside slope of the levee looking downstream.	
pkazi_f_20121114_061.jpg

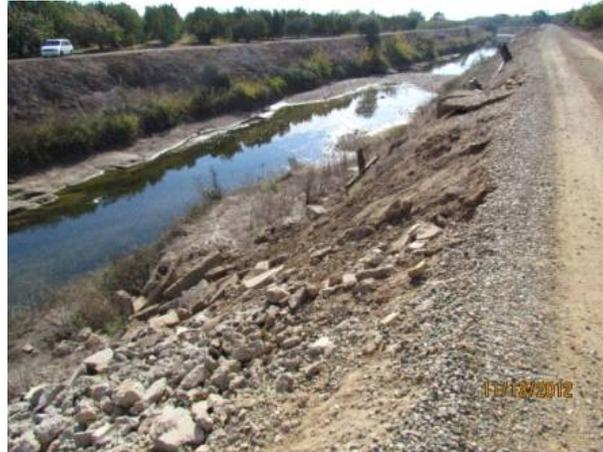
Levee Mile Report Line	55
Start Levee Mile	3.86
End Levee Mile	3.86
Location	Water Side
Category	Earthen Levee
Item	Slope Stability
Slope instability was found on the landside slope of the levee looking downstream.	
pkazi_f_20121114_062.jpg

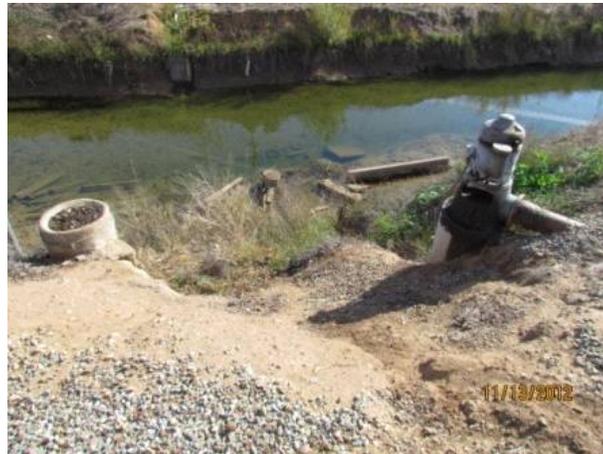
Levee Mile Report Line	57
Start Levee Mile	3.97
End Levee Mile	3.97
Location	Water Side
Category	Earthen Levee
Item	Slope Stability
Slope instability was found on the landside slope of the levee looking downstream.	
pkazi_f_20121114_063.jpg

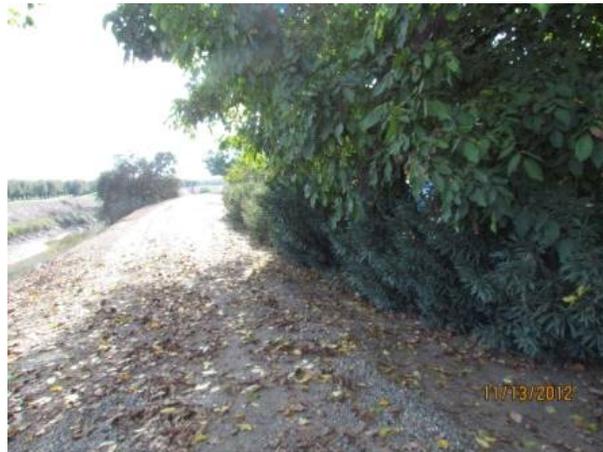
Levee Mile Report Line	60
Start Levee Mile	4.13
End Levee Mile	4.15
Location	Land Side
Category	Earthen Levee
Item	Vegetation
Landscape was blocking the visibility on the landside of the levee looking downstream.	
pkazi_f_20121114_064.jpg

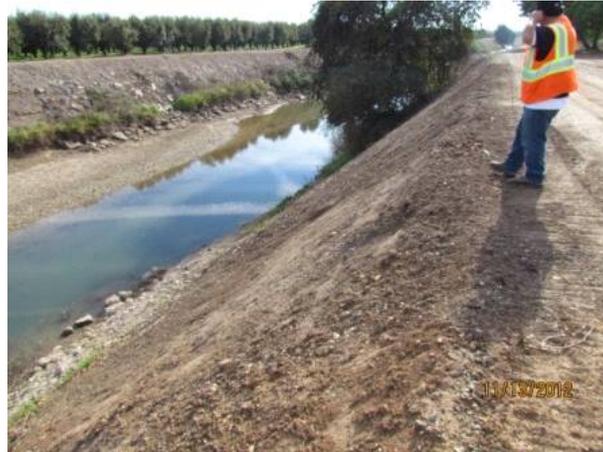
Levee Mile Report Line	62
Start Levee Mile	4.15
End Levee Mile	4.15
Location	Water Side
Category	Earthen Levee
Item	Slope Stability
<p>The LMA has fixed the slope instability issue on the landside slope of the levee looking downstream.</p>	
<p>pkazi_f_20121114_065.jpg</p>

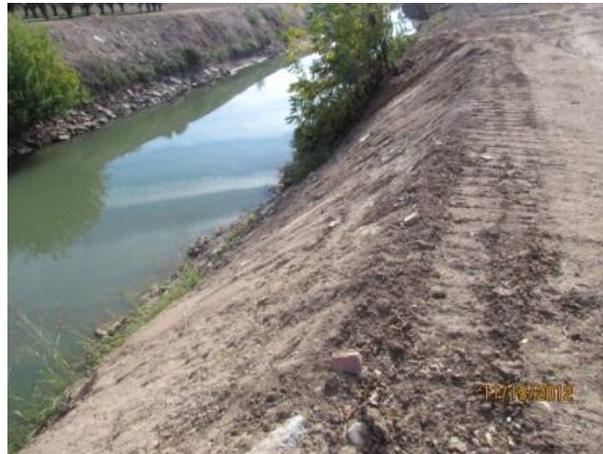
Levee Mile Report Line	68
Start Levee Mile	4.27
End Levee Mile	4.27
Location	Water Side
Category	Earthen Levee
Item	Slope Stability
<p>The LMA has fixed the slope instability issue on the landside slope of the levee looking downstream.</p>	
<p>pkazi_f_20121114_066.jpg</p>

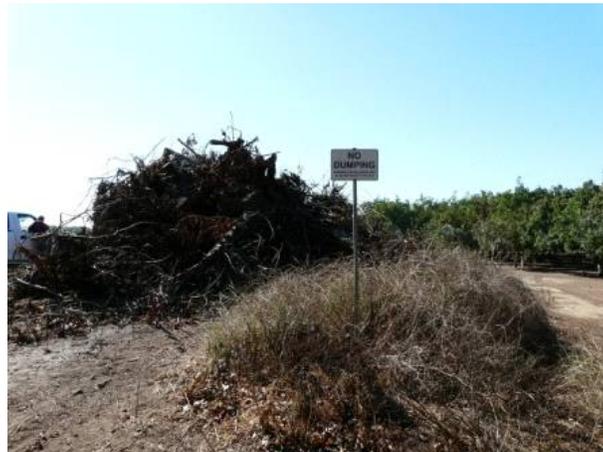
Levee Mile Report Line	69
Start Levee Mile	4.29
End Levee Mile	4.29
Location	Land Side
Category	Earthen Levee
Item	Encroachments
<p>Example of a prunings pile immediately adjacent to access road at LM 4.29. Evidence of habitual burnings at this site.</p>	
<p>pkazi_f_20120913_307.JPG</p>

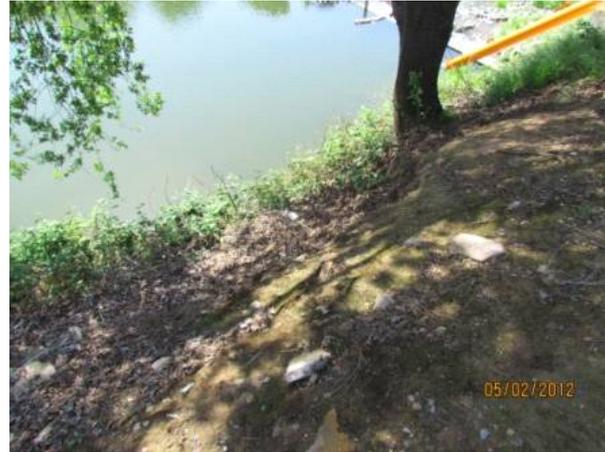
Levee Mile Report Line	71
Start Levee Mile	4.73
End Levee Mile	4.73
Location	Water Side
Category	Earthen Levee
Item	Erosion / Bank Caving
Erosion was found on the waterside slope of the levee looking downstream.	
pkazi_f_20120913_365.jpg

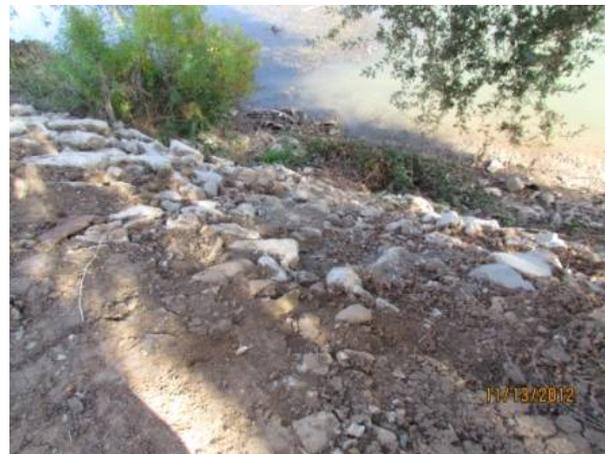
Levee Mile Report Line	71
Start Levee Mile	4.73
End Levee Mile	4.73
Location	Water Side
Category	Earthen Levee
Item	Erosion / Bank Caving
The LMA has fixed the erosion on the landside slope of the levee but the riprap contains exposed rebar which could be dangerous during a flood fight.	
pkazi_f_20121114_067.jpg

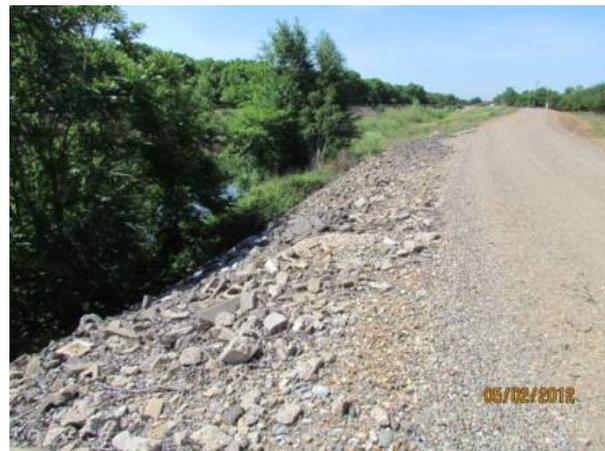
Levee Mile Report Line	72
Start Levee Mile	4.80
End Levee Mile	4.80
Location	Water Side
Category	Earthen Levee
Item	Encroachments
Debris was found on the waterside of the levee looking downstream.	
pkazi_f_20120913_367.jpg

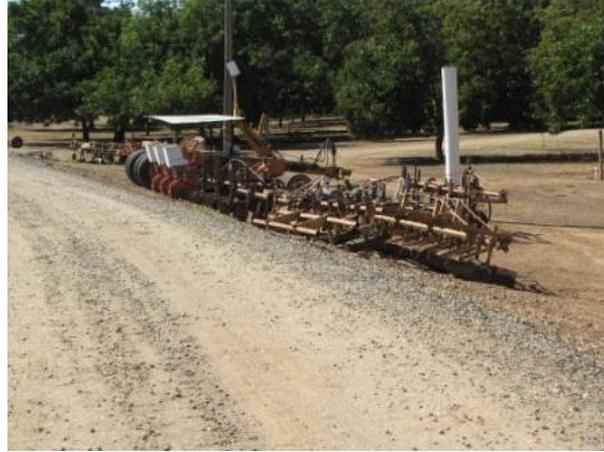
Levee Mile Report Line	73
Start Levee Mile	4.96
End Levee Mile	4.96
Location	Land Side
Category	Earthen Levee
Item	Encroachments
View of equipment along the landward slope looking downstream.	
pkazi_f_20120913_308.jpg

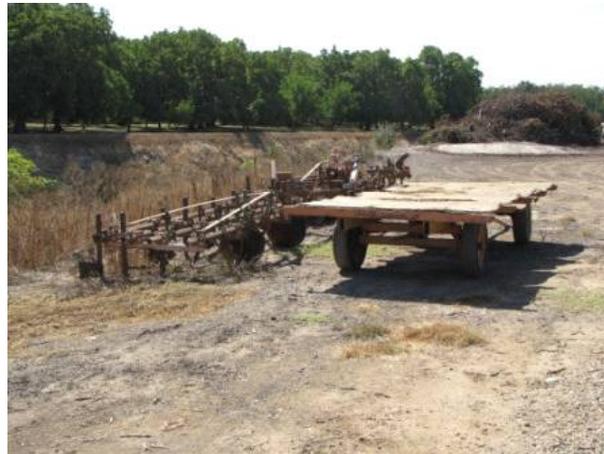
Levee Mile Report Line	74
Start Levee Mile	4.96
End Levee Mile	4.96
Location	Water Side
Category	Earthen Levee
Item	Encroachments
View of equipment along the waterward side of the levee crown looking downstream.	
pkazi_f_20120913_309.jpg

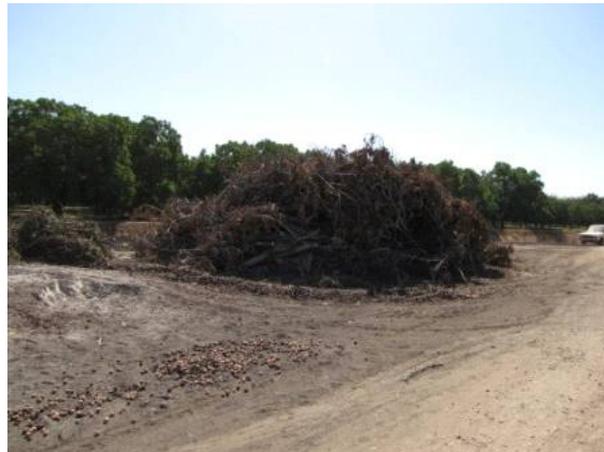
Levee Mile Report Line	75
Start Levee Mile	4.97
End Levee Mile	4.97
Location	Water Side
Category	Earthen Levee
Item	Encroachments
View of prunings pile along the waterward side of the crown looking downstream.	
pkazi_f_20120913_350.jpg

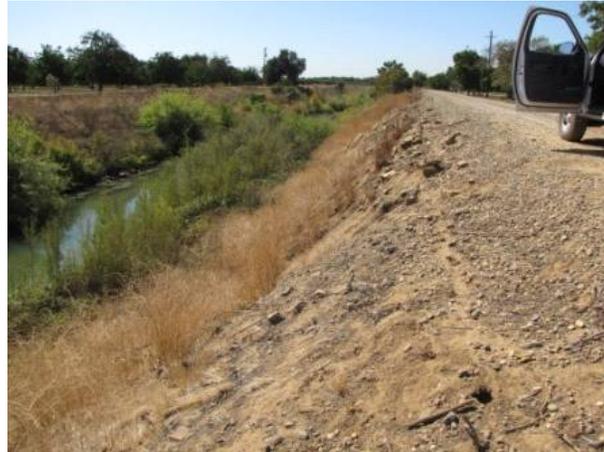
pkazi_f_20120913_410.jpg

View of a slip in the waterward levee slope looking downstream.

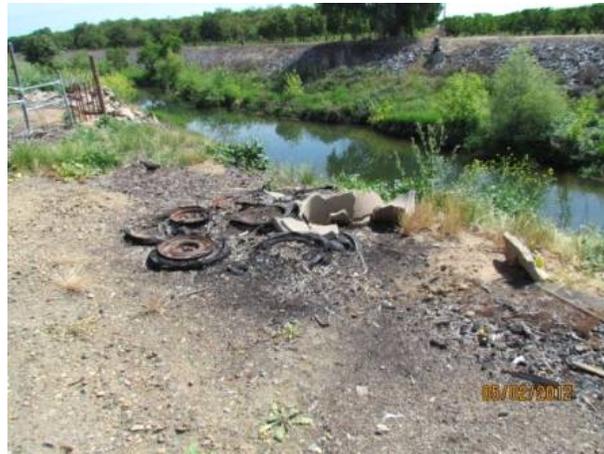
pkazi_f_20120913_310.jpg

Levee Mile Report Line	82
Start Levee Mile	5.27
End Levee Mile	5.27
Location	Water Side
Category	Earthen Levee
Item	Encroachments

Debris was found on the waterside of the levee looking upstream.

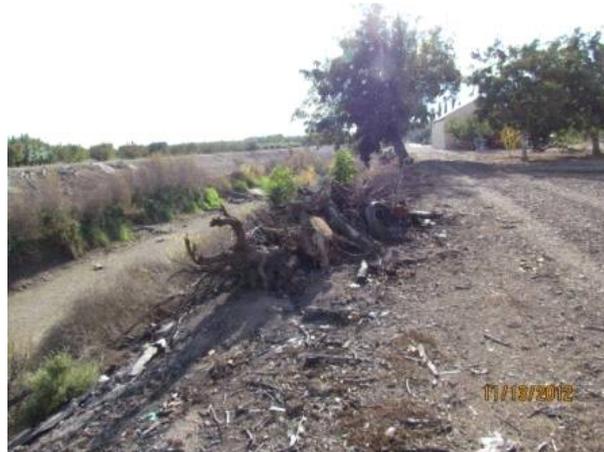
pkazi_f_20121114_068.jpg

Levee Mile Report Line	83
Start Levee Mile	5.31
End Levee Mile	5.31
Location	Water Side
Category	Earthen Levee
Item	Encroachments

Pruning was found on the waterside slope of the levee looking downstream.

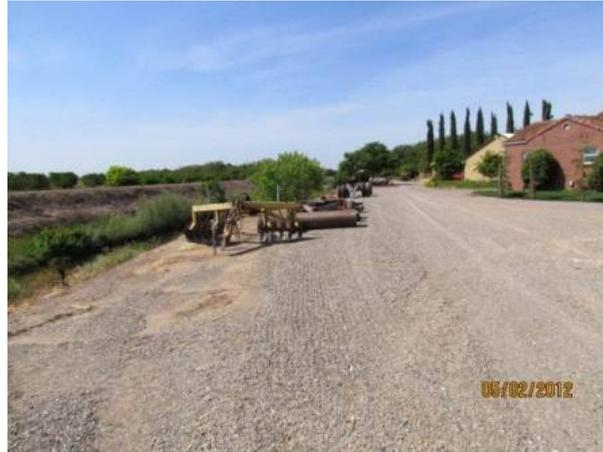
Levee Mile Report Line	84
Start Levee Mile	5.37
End Levee Mile	5.37
Location	Water Side
Category	Earthen Levee
Item	Encroachments
Equipment was found on the waterside of the levee looking downstream.	
pkazi_f_20120913_372.jpg

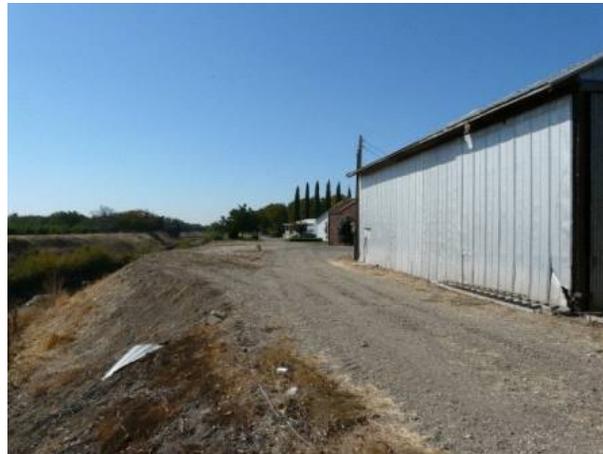
Levee Mile Report Line	85
Start Levee Mile	5.38
End Levee Mile	5.45
Location	Land Side
Category	Earthen Levee
Item	Encroachments
Building located immediately adjacent to access road approximately from LM 5.38 to 5.45	
pkazi_f_20120913_311.JPG

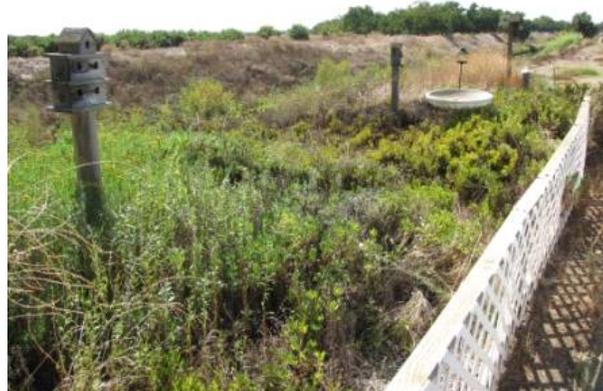
Levee Mile Report Line	86
Start Levee Mile	5.42
End Levee Mile	5.42
Location	Water Side
Category	Earthen Levee
Item	Vegetation
View of landscaping planted along the waterward side of the access road impacting visibility and the ability to floodfight looking downstream.	
pkazi_f_20120913_411.jpg

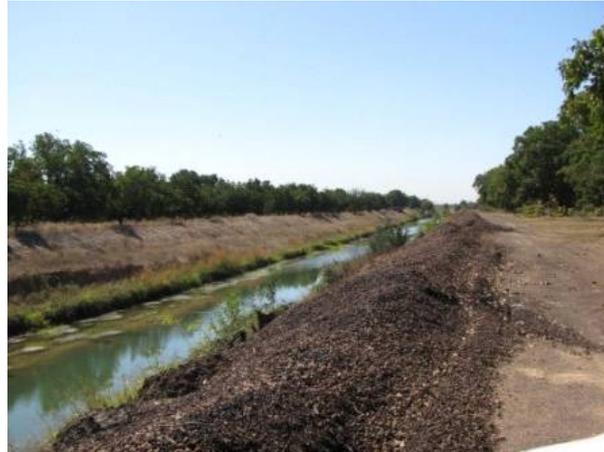
pkazi_f_20120913_412.jpg

View of discarded nut shells placed along the waterward slope to be burned looking downstream.

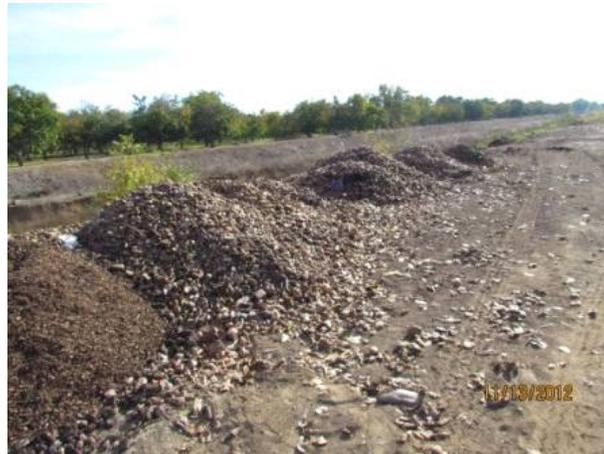
pkazi_f_20121114_069.jpg

Levee Mile Report Line	87
Start Levee Mile	5.60
End Levee Mile	5.65
Location	Water Side
Category	Earthen Levee
Item	Encroachments

In addition to the walnut piles, there were rocks and debris were found at the landside shoulder of the levee looking downstream.

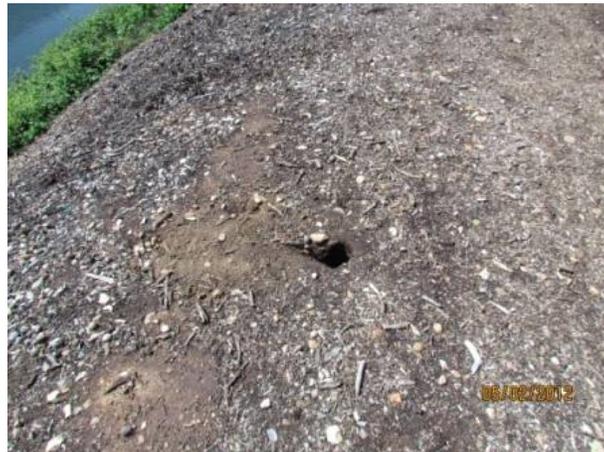
pkazi_f_20120913_413.jpg

Levee Mile Report Line	88
Start Levee Mile	5.68
End Levee Mile	5.68
Location	Water Side
Category	Earthen Levee
Item	Animal Control

An animal hole was found on the waterside of the levee looking downstream.

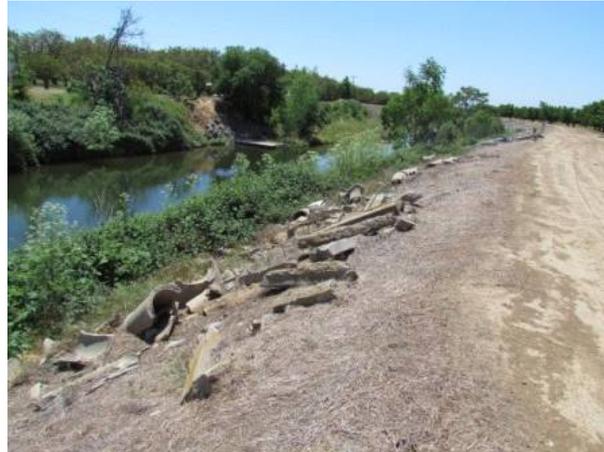
Levee Mile Report Line	89
Start Levee Mile	5.76
End Levee Mile	5.86
Location	Water Side
Category	Earthen Levee
Item	Encroachments
<p>Broken concrete pipes and other debris was found on the waterside of the levee. The picture was taken from the crown looking downstream.</p>	
<p>pkazi_f_20120913_312.jpg</p>

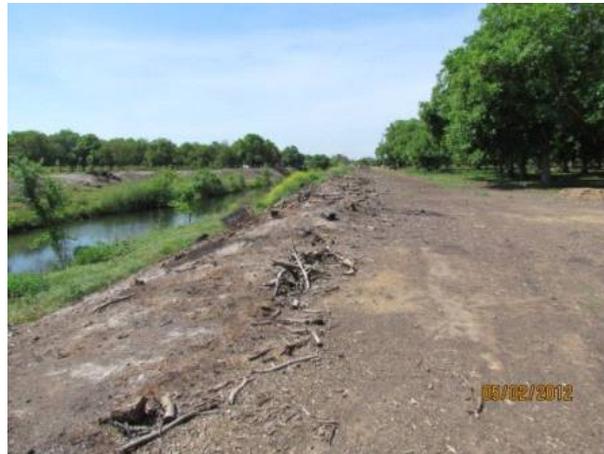
Levee Mile Report Line	89
Start Levee Mile	5.76
End Levee Mile	5.86
Location	Water Side
Category	Earthen Levee
Item	Encroachments
<p>Debris was still on the waterside of the levee looking downstream. This picture was taken during Spring 2012 inspection.</p>	
<p>pkazi_f_20120913_313.jpg</p>

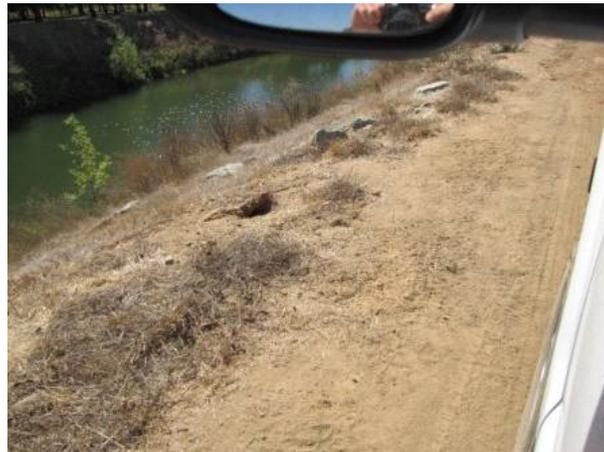
Levee Mile Report Line	90
Start Levee Mile	5.92
End Levee Mile	5.92
Location	Water Side
Category	Earthen Levee
Item	Animal Control
<p>View of rodent activity in the waterward slope looking downstream.</p>	
<p>pkazi_f_20120913_355.jpg</p>

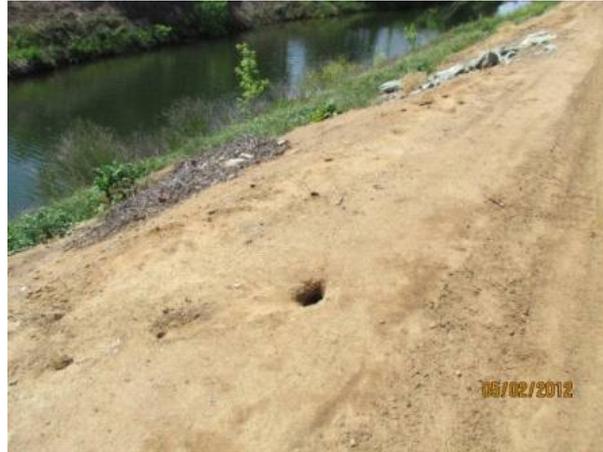
Levee Mile Report Line	90
Start Levee Mile	5.92
End Levee Mile	5.92
Location	Water Side
Category	Earthen Levee
Item	Animal Control
<p>Animal holes were found on the waterside of the levee looking downstream. This picture was taken during Spring 2012 Inspection.</p>	
<p>pkazi_f_20120913_356.jpg</p>

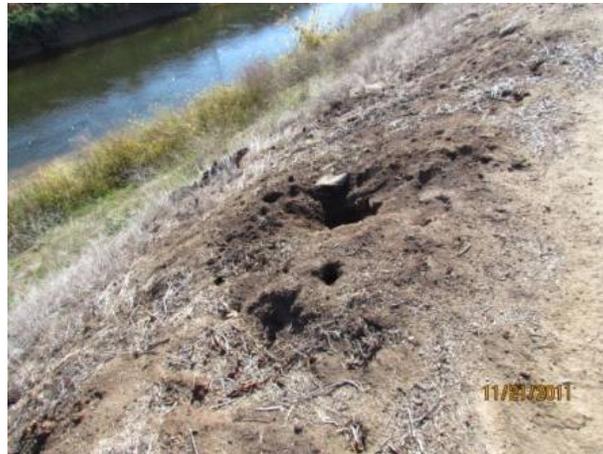
Levee Mile Report Line	93
Start Levee Mile	6.14
End Levee Mile	6.14
Location	Water Side
Category	Earthen Levee
Item	Animal Control
<p>Rodent holes were found on the waterside of the levee looking downstream.</p>	
<p>pkazi_f_20120913_360.jpg</p>

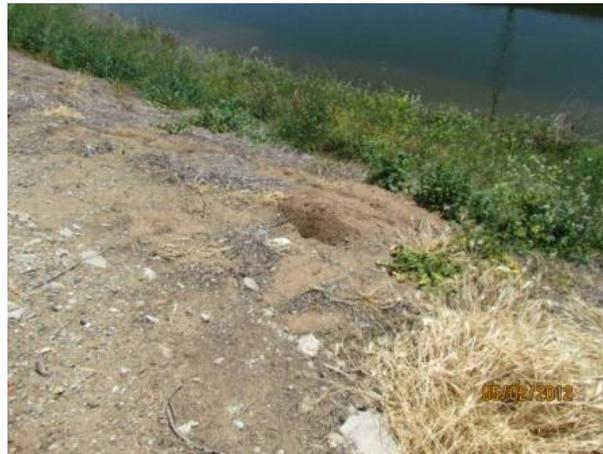
Levee Mile Report Line	94
Start Levee Mile	6.19
End Levee Mile	6.19
Location	Water Side
Category	Earthen Levee
Item	Animal Control
<p>An animal hole was found on the waterside of the levee looking upstream.</p>	
<p>pkazi_f_20120913_375.jpg</p>

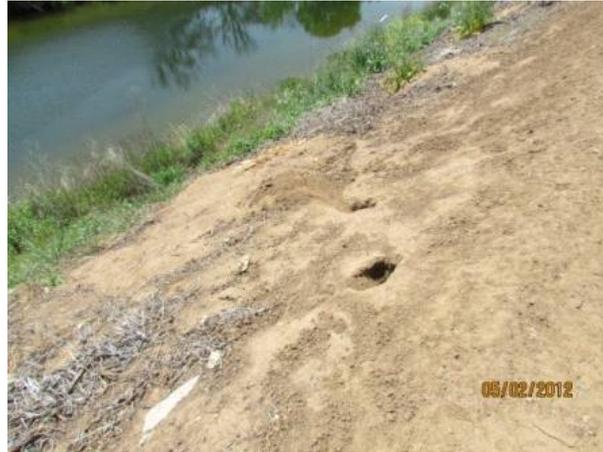
Levee Mile Report Line	95
Start Levee Mile	6.20
End Levee Mile	6.20
Location	Water Side
Category	Earthen Levee
Item	Animal Control
Animal holes were found on the waterside of the levee looking downstream.	
pkazi_f_20120913_376.jpg

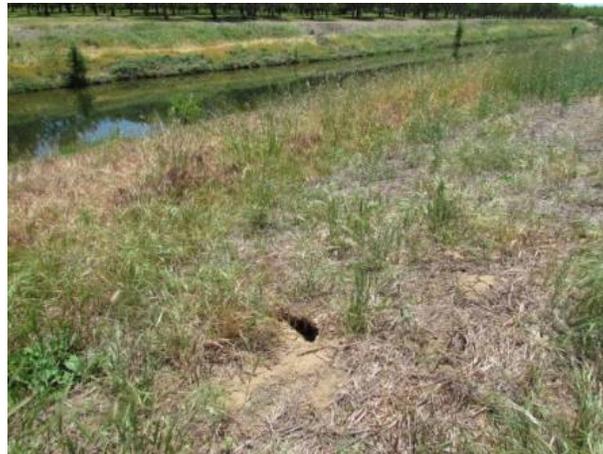
Levee Mile Report Line	99
Start Levee Mile	6.58
End Levee Mile	6.58
Location	Water Side
Category	Earthen Levee
Item	Animal Control
A rodent hole was found on the waterside of the levee. The picture was taken from the crown looking downstream.	
pkazi_f_20120913_366.jpg

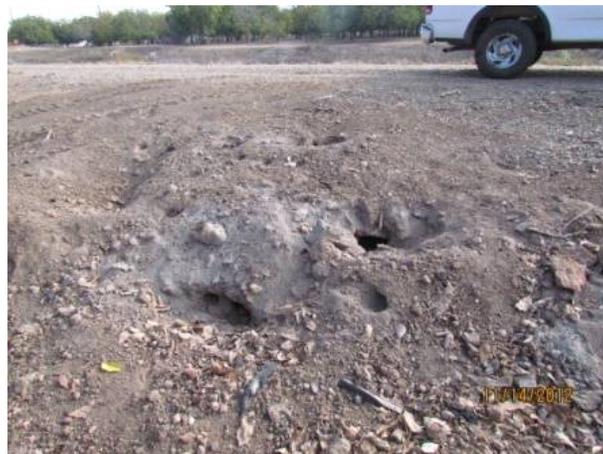
Levee Mile Report Line	101
Start Levee Mile	6.60
End Levee Mile	6.60
Location	Land Side
Category	Earthen Levee
Item	Animal Control
Animal holes were found on the landside slope of the levee looking downstream.	
pkazi_f_20121118_070.jpg

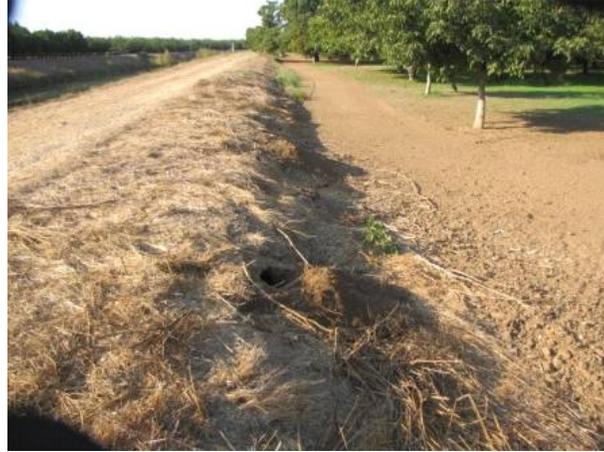
Levee Mile Report Line	102
Start Levee Mile	6.61
End Levee Mile	6.61
Location	Land Side
Category	Earthen Levee
Item	Animal Control
View of rodent activity in the landward slope looking downstream.	
pkazi_f_20120913_361.jpg

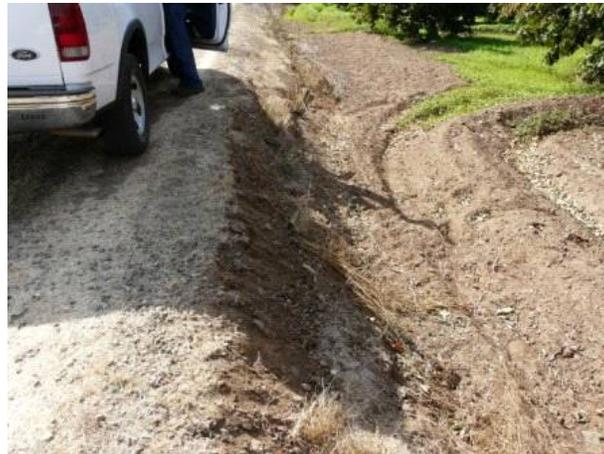
Levee Mile Report Line	103
Start Levee Mile	6.75
End Levee Mile	6.88
Location	Land Side
Category	Earthen Levee
Item	Erosion / Bank Caving
Farming equipment grading into the landside toe of the levee located at LM 6.90. Backfill and compact to design shape and attempt to prevent future damage.	
pkazi_f_20120913_353.JPG

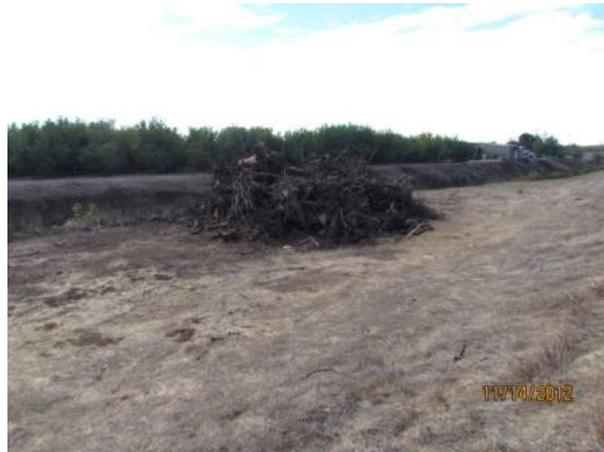
Levee Mile Report Line	104
Start Levee Mile	6.89
End Levee Mile	6.89
Location	Water Side
Category	Earthen Levee
Item	Encroachments
Prunings were found on the waterside shoulder of the levee looking downstream.	
pkazi_f_20121118_071.jpg

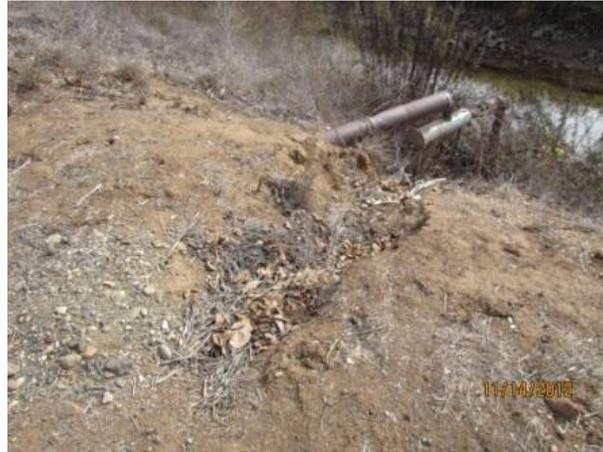
Levee Mile Report Line	106
Start Levee Mile	7.13
End Levee Mile	7.13
Location	Water Side
Category	Earthen Levee
Item	Slope Stability
Erosion was found on the waterside shoulder of the levee looking downstream.	
pkazi_f_20121118_072.jpg

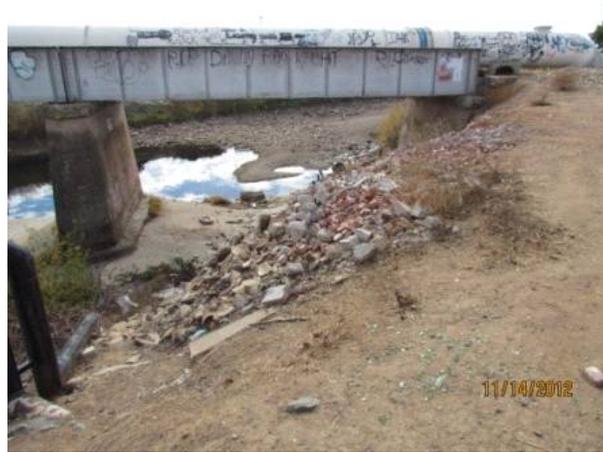
Levee Mile Report Line	110
Start Levee Mile	7.36
End Levee Mile	7.36
Location	Water Side
Category	Earthen Levee
Item	Encroachments
Debris was found on the waterside slope of the levee looking downstream.	
pkazi_f_20121118_073.jpg

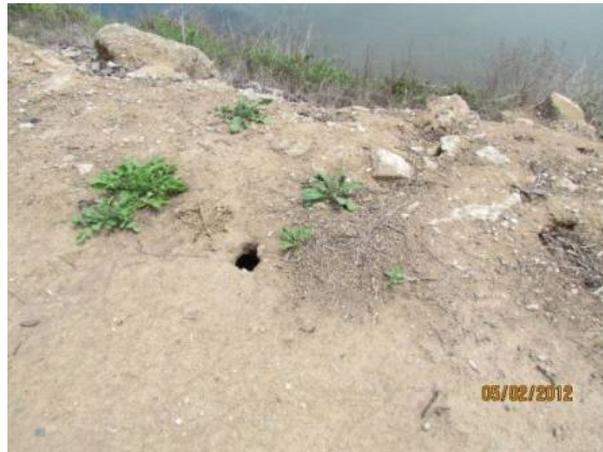
Levee Mile Report Line	111
Start Levee Mile	7.42
End Levee Mile	7.42
Location	Water Side
Category	Earthen Levee
Item	Animal Control
An animal hole was found on the waterside of the levee looking upstream.	
pkazi_f_20120913_380.jpg

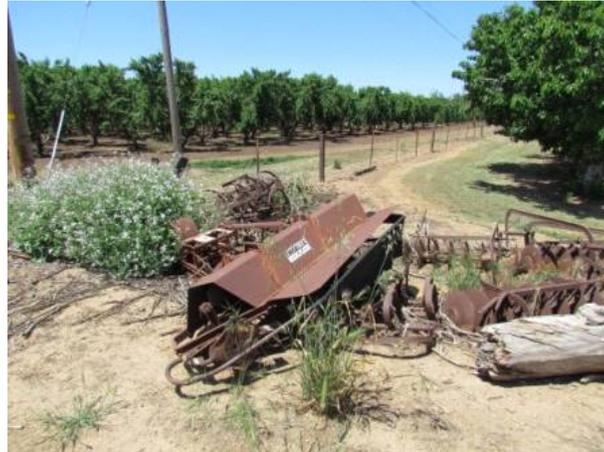
Levee Mile Report Line	114
Start Levee Mile	7.98
End Levee Mile	7.98
Location	Land Side
Category	Earthen Levee
Item	Encroachments
Equipments were left out by the farmers on the landside of the levee. The picture was taken from crown looking toward the landside of the levee.	
pkazi_f_20120913_391.jpg

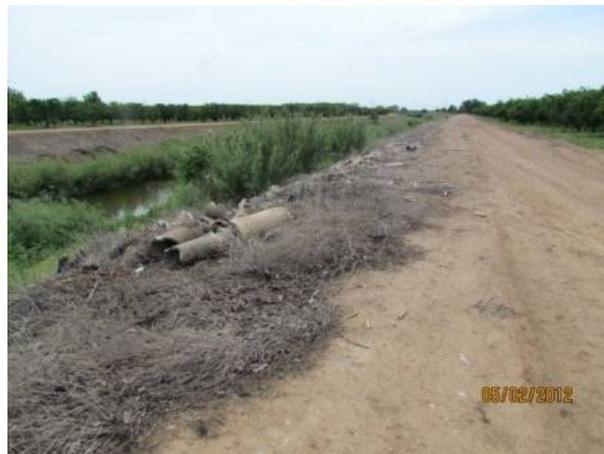
Levee Mile Report Line	115
Start Levee Mile	8.05
End Levee Mile	8.05
Location	Water Side
Category	Earthen Levee
Item	Encroachments
Debris was found on the waterside of the levee looking downstream.	
pkazi_f_20120913_382.jpg

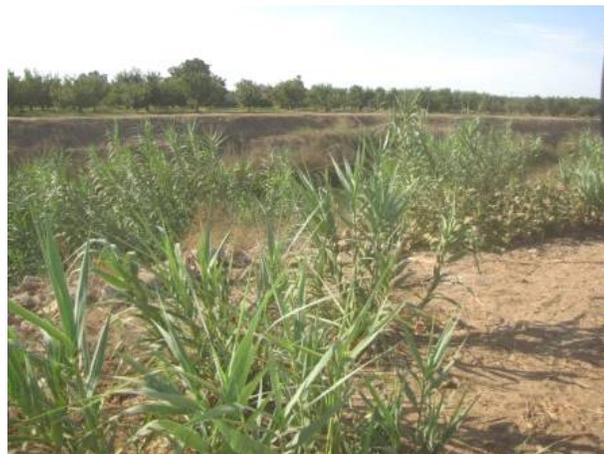
Levee Mile Report Line	116
Start Levee Mile	8.06
End Levee Mile	8.06
Location	Water Side
Category	Earthen Levee
Item	Vegetation
View of arrundo on the waterward shoulder and slope blocking visibility looking downstream.	
pkazi_f_20120913_369.jpg

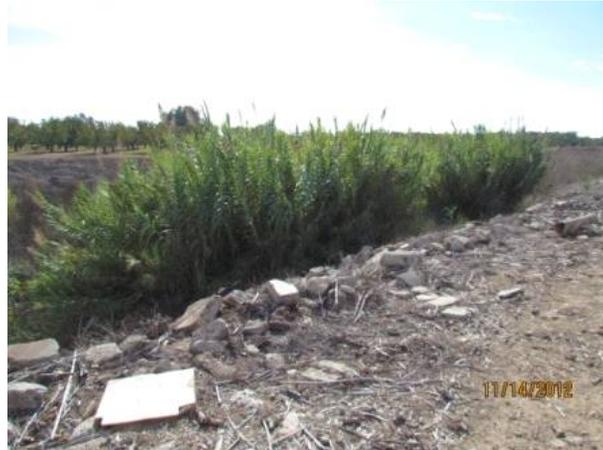
Levee Mile Report Line	116
Start Levee Mile	8.06
End Levee Mile	8.06
Location	Water Side
Category	Earthen Levee
Item	Vegetation
Updated picture of the Arundo on the waterside slope of the levee looking downstream.	
pkazi_f_20121118_074.jpg

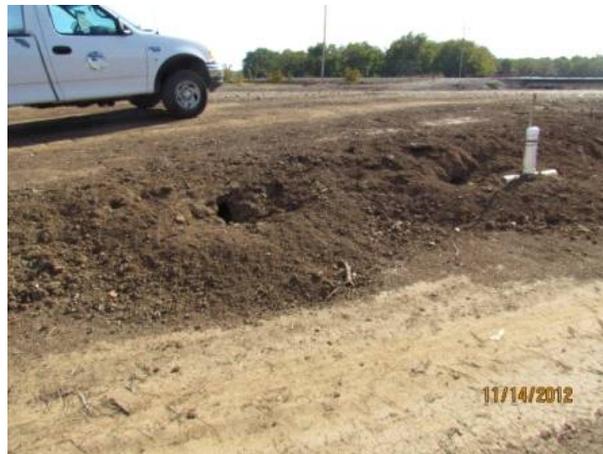
Levee Mile Report Line	118
Start Levee Mile	8.28
End Levee Mile	8.28
Location	Land Side
Category	Earthen Levee
Item	Animal Control
View of the animal holes on the landside slope of the levee looking downstream.	
pkazi_f_20121118_075.jpg

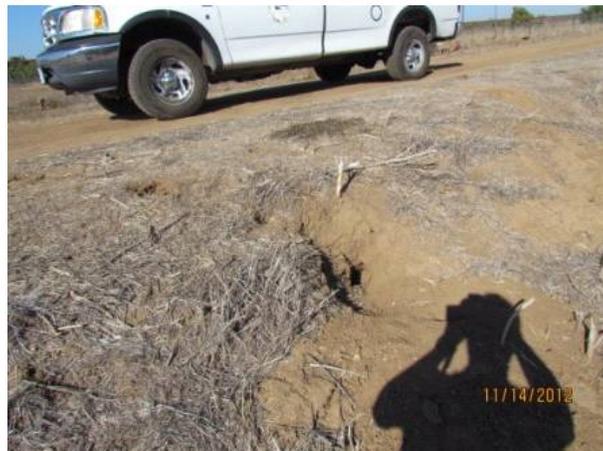
Levee Mile Report Line	120
Start Levee Mile	8.44
End Levee Mile	8.44
Location	Water Side
Category	Earthen Levee
Item	Animal Control
View of the animal hole on the waterside slope of the levee looking upstream.	
pkazi_f_20121118_076.jpg

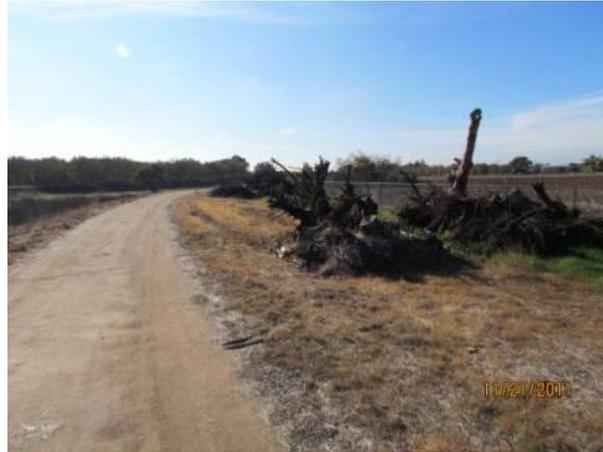
Levee Mile Report Line	121
Start Levee Mile	8.47
End Levee Mile	8.50
Location	Land Side
Category	Earthen Levee
Item	Encroachments
Prunings were found on the landside of the levee looking downstream.	
pkazi_f_20120913_437.jpg

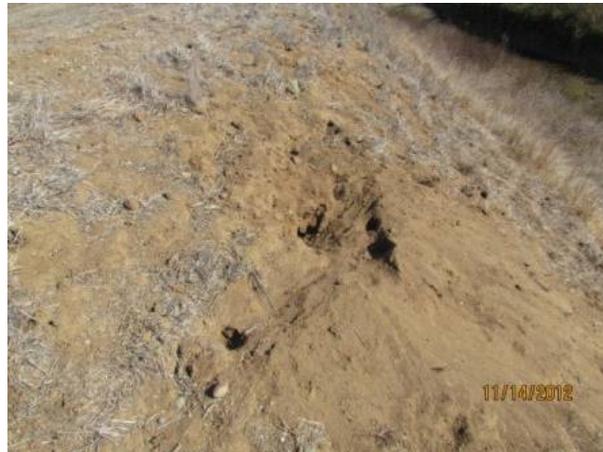
Levee Mile Report Line	123
Start Levee Mile	8.64
End Levee Mile	8.64
Location	Water Side
Category	Earthen Levee
Item	Animal Control
Animal holes were found on the waterside slope of the levee looking upstream.	
pkazi_f_20121118_077.jpg

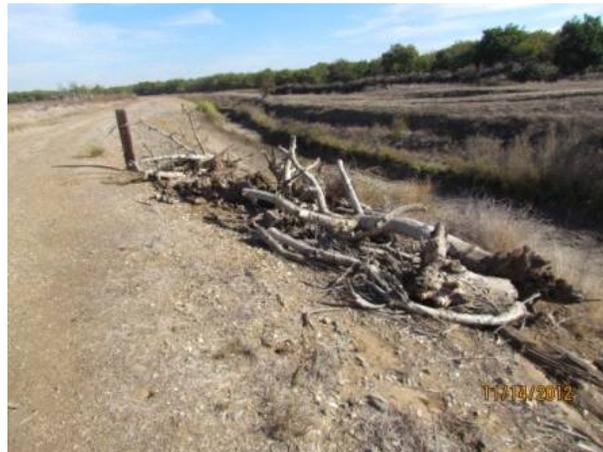
Levee Mile Report Line	124
Start Levee Mile	8.66
End Levee Mile	8.66
Location	Water Side
Category	Earthen Levee
Item	Encroachments
Prunings were found on the waterside slope of the levee looking upstream.	
pkazi_f_20121118_078.jpg

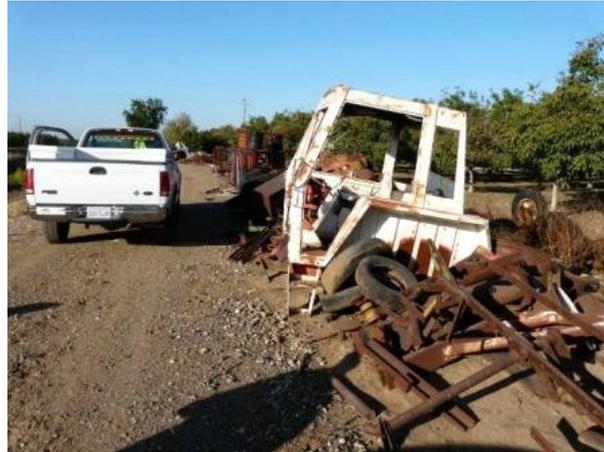
Levee Mile Report Line	125
Start Levee Mile	8.68
End Levee Mile	8.70
Location	Land Side
Category	Earthen Levee
Item	Encroachments
Remove equipment from landside slope of levee at from LM 8.68 to LM 8.70.	
pkazi_f_20120913_321.JPG
